# **The Road Inventory of William L Finley National Wildlife Refuge Corvallis, OR**

Prepared By:  
Federal Highway Administration  
Central Federal Lands Highway Division  
February 2013

# William L Finley NWR - 13589

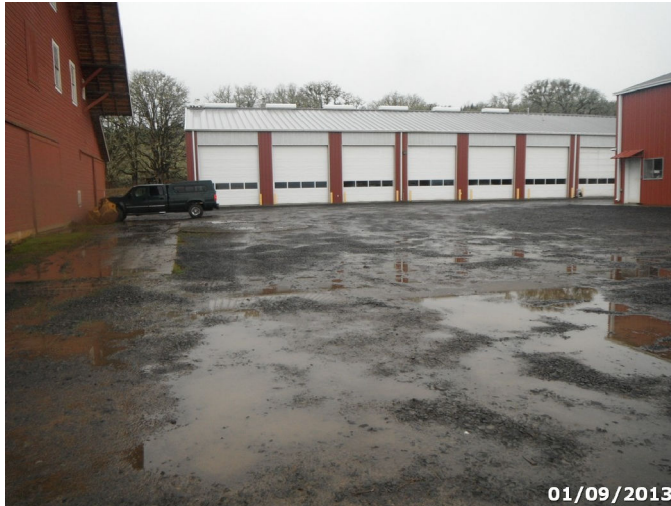
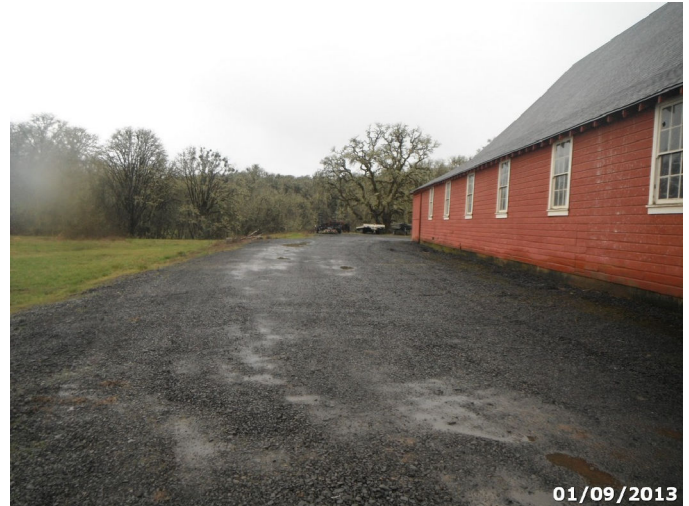
## Route Number: 800

### Shop Parking

From Finley Refuge Road (Route 010)

Asset Number	Area (Sq Ft)	Spaces	Condition	Surface Type	Cost to Improve	Inspection Date	Current Replacement Value
10048218	55904	20	Good	Gravel	\$9,600	01-09-2013	\$316,800

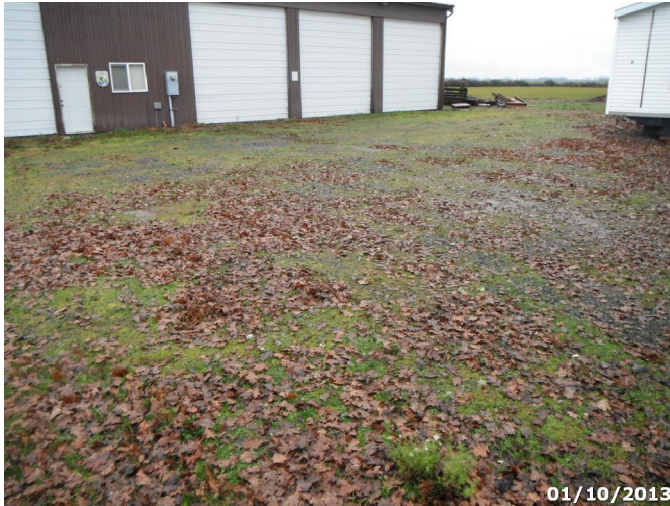
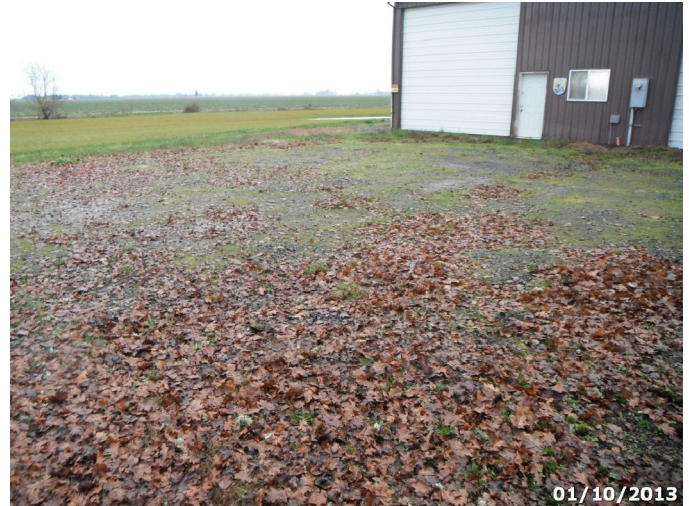
# Route Number: 801

From Snag Boat Bend East Administrative Access Road (Route 408)

Asset Number	Area (Sq Ft)	Spaces	Condition	Surface Type	Cost to Improve	Inspection Date	Current Replacement Value
10048914	5857	10	Fair	Gravel	\$1,800	01-10-2013	\$33,200

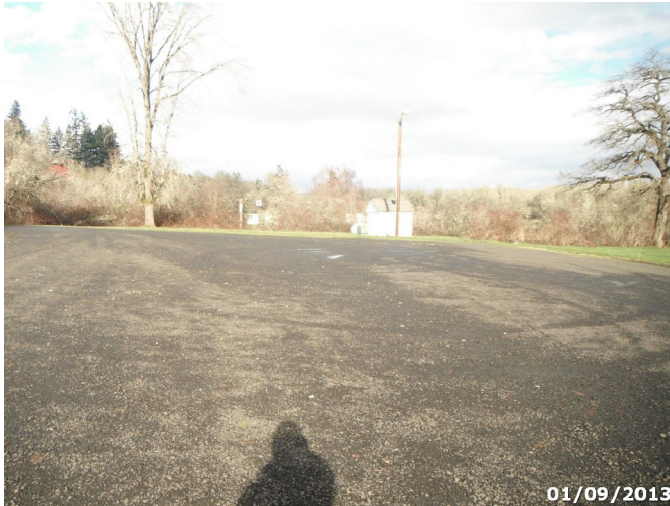
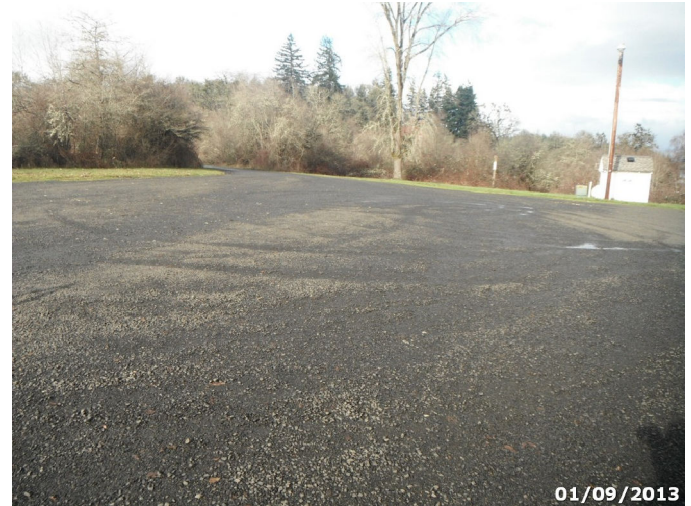
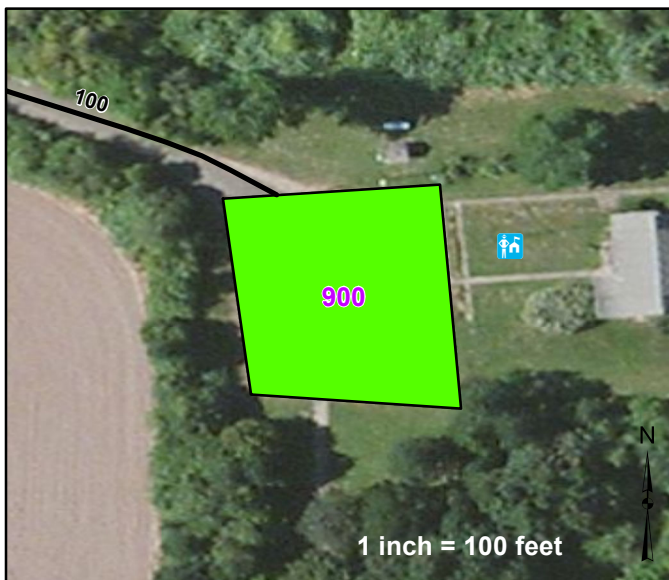
# Route Number: 900

From Cambell Lodge Parking (Route 100)

Asset Number	Area (Sq Ft)	Spaces	Condition	Surface Type	Cost to Improve	Inspection Date	Current Replacement Value
10048878	8709	10	Good	Gravel	\$1,500	01-09-2013	\$49,300

Routes modified from previous inventory:			
Rte #	Rte Name	Type of Modification	Description of Modification
907	Bruce Road Overlook Parking	New GPS Trace	
906	Pigeon Springs Parking	Name Change	Changed from Pigeon Butte Parking Lot
901	Prairie Overlook Parking	New GPS Trace/ Name Change	Changed from Parking Lot #1
900	Cambell Lodge Parking	Name Change	Changed from Refuge Office Parking

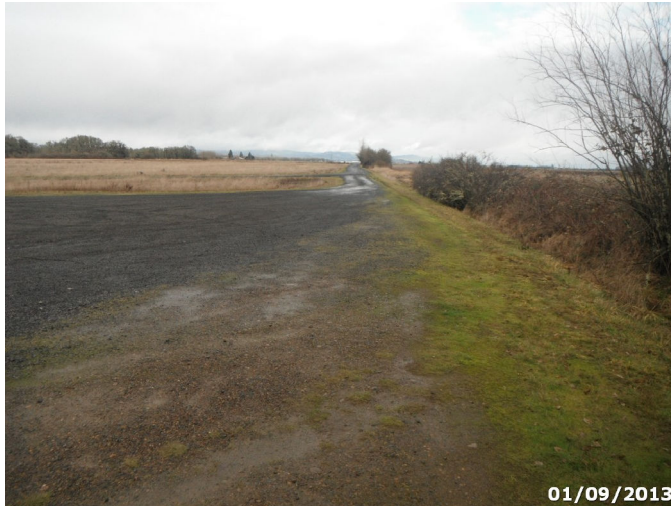
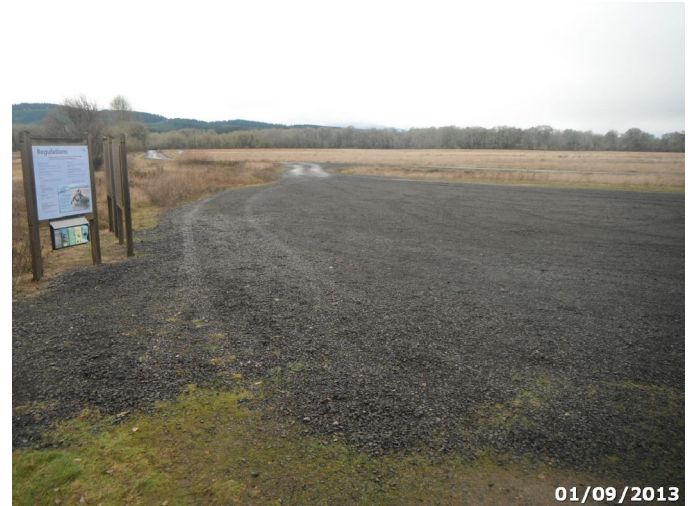
**Route Number: 901**  
**Prairie Overlook Parking**  
 From Finley Refuge Road (Route 010)

Asset Number	Area (Sq Ft)	Spaces	Condition	Surface Type	Cost to Improve	Inspection Date	Current Replacement Value
-	13781	10	Good	Gravel	\$2,400	01-09-2013	\$78,100

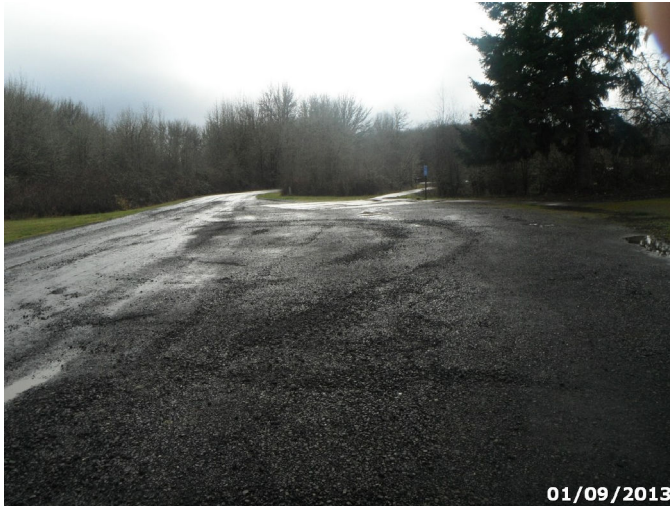
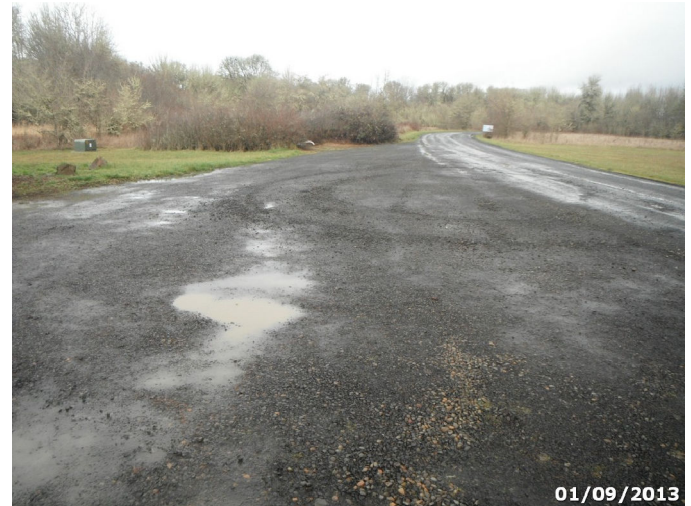
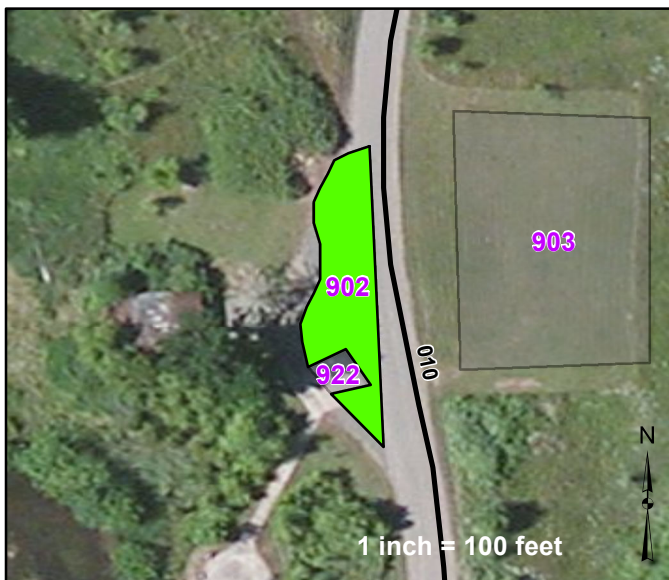
## Route Number: 902

From Finley Refuge Road (Route 010)

Asset Number	Area (Sq Ft)	Spaces	Condition	Surface Type	Cost to Improve	Inspection Date	Current Replacement Value
10048907	2771	5	Good	Gravel	\$500	01-09-2013	\$15,700

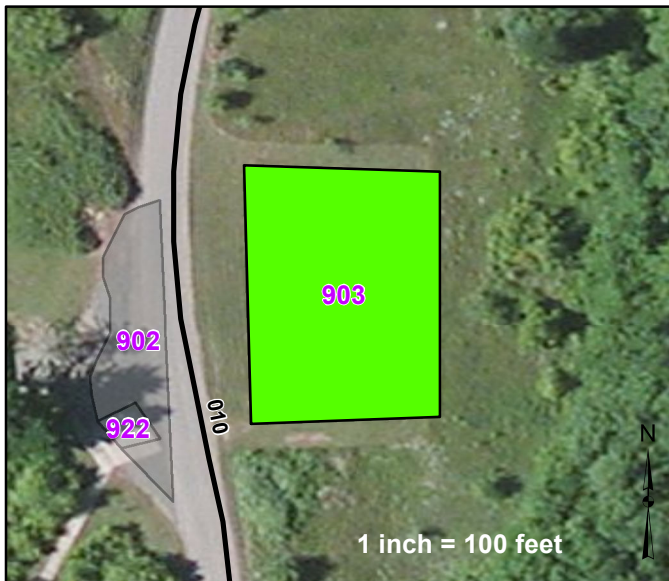
## Route Number: 903

From Finley Refuge Road (Route 010)

Asset Number	Area (Sq Ft)	Spaces	Condition	Surface Type	Cost to Improve	Inspection Date	Current Replacement Value
10048993	9425	50	Good	Native	\$1,600	05-24-2004	\$23,000

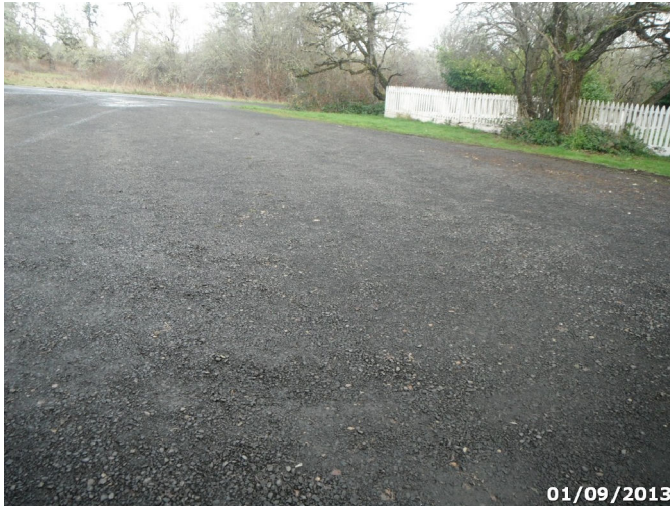
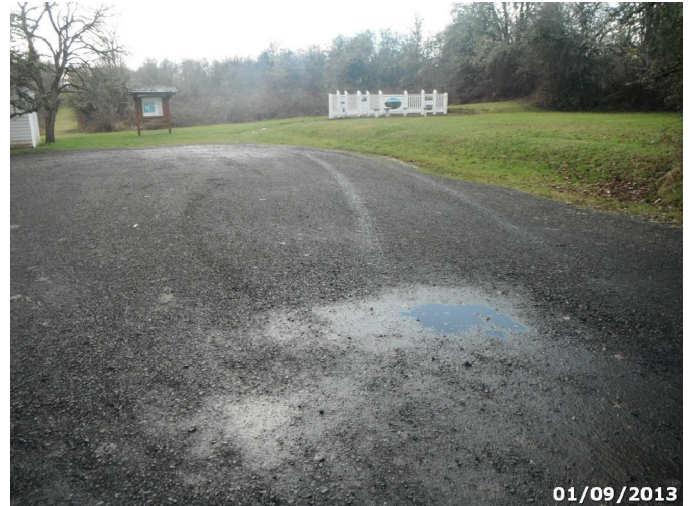
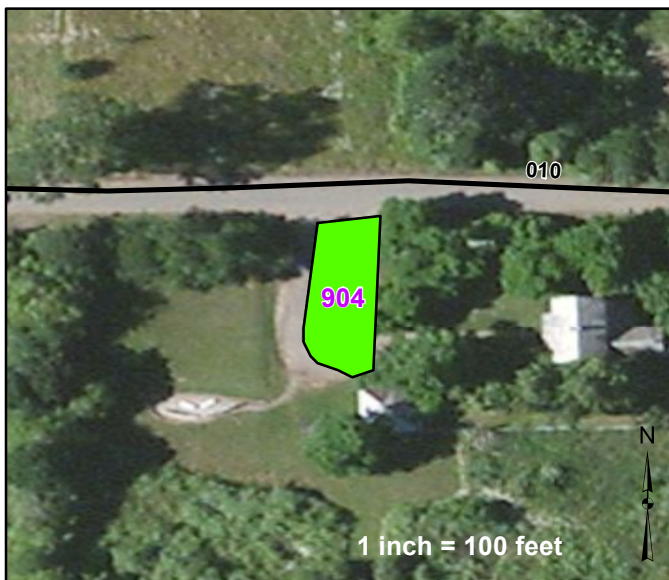
**Route Number: 904**  
**Feichter House Parking**  
 From Finley Refuge Road (Route 010)

Asset Number	Area (Sq Ft)	Spaces	Condition	Surface Type	Cost to Improve	Inspection Date	Current Replacement Value
10048879	1960	10	Good	Gravel	\$300	05-24-2004	\$11,100

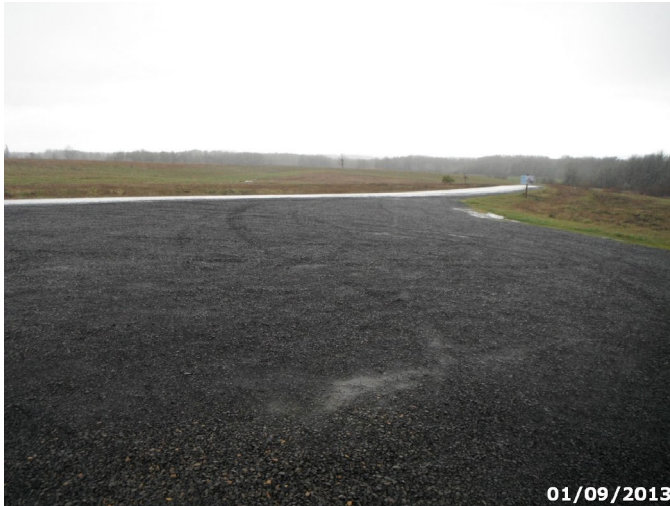
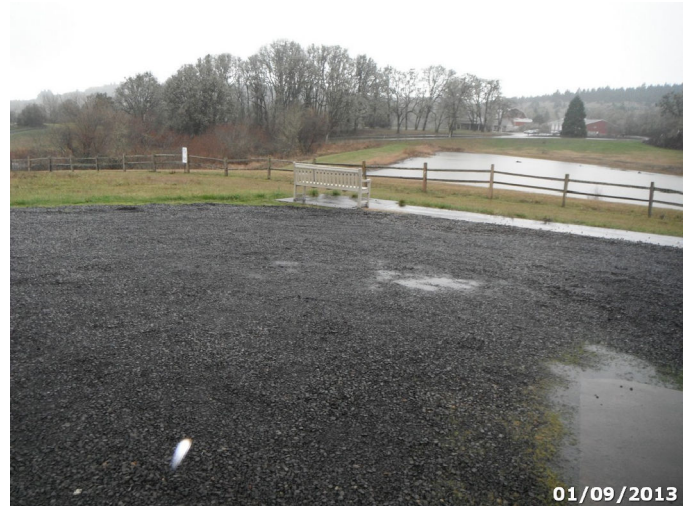
# Route Number: 905

Asset Number	Area (Sq Ft)	Spaces	Condition	Surface Type	Cost to Improve	Inspection Date	Current Replacement Value
10048874	5206	8	Good	Gravel	\$900	01-09-2013	\$29,500

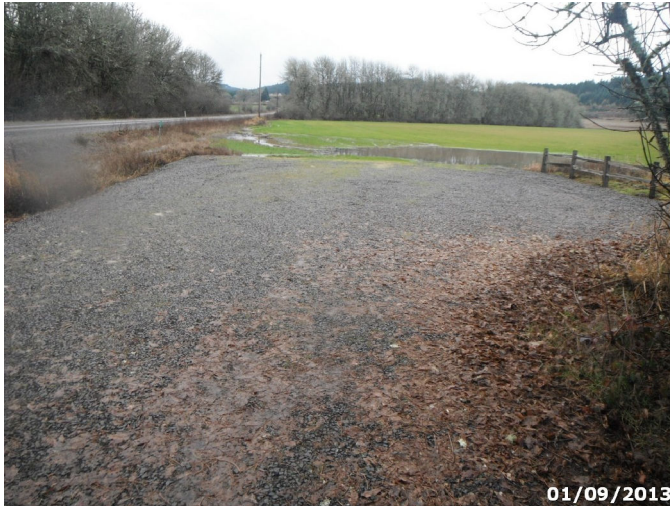
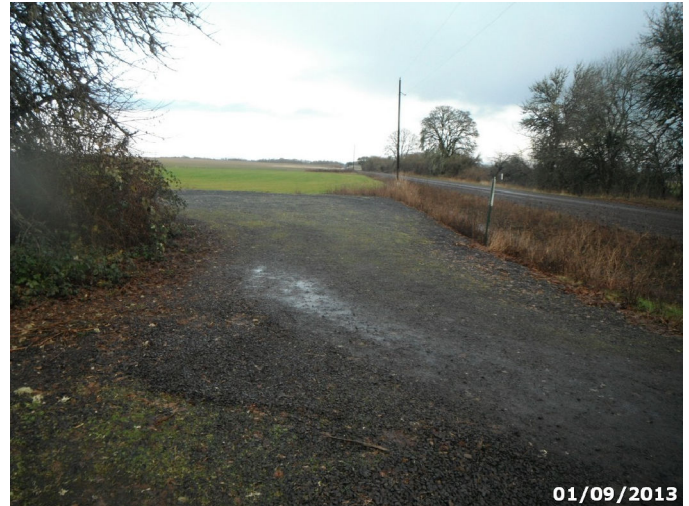
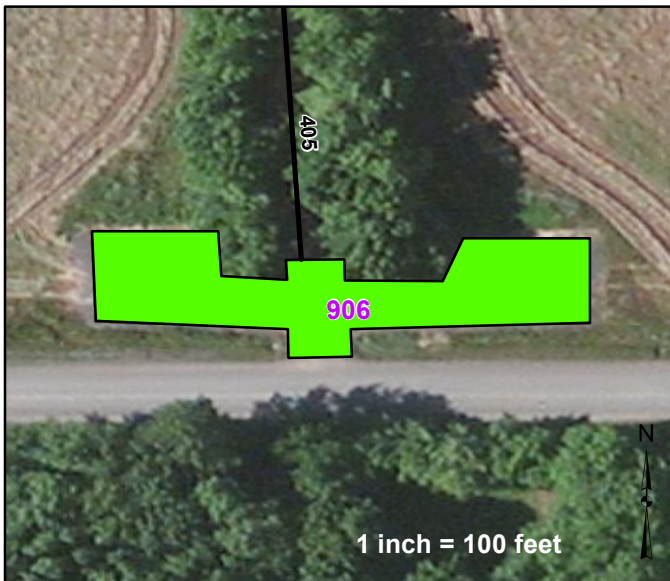
**Route Number: 906**  
**Pigeon Springs Parking**  
**From Bruce Road**

Asset Number	Area (Sq Ft)	Spaces	Condition	Surface Type	Cost to Improve	Inspection Date	Current Replacement Value
10048179	7275	20	Good	Gravel	\$1,200	01-09-2013	\$41,200

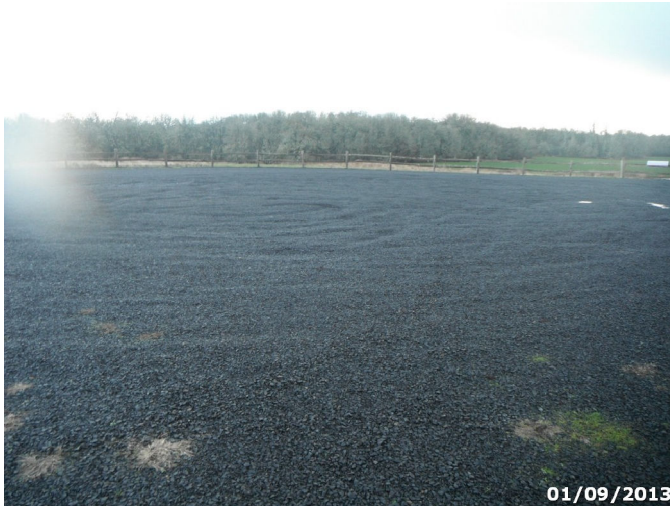
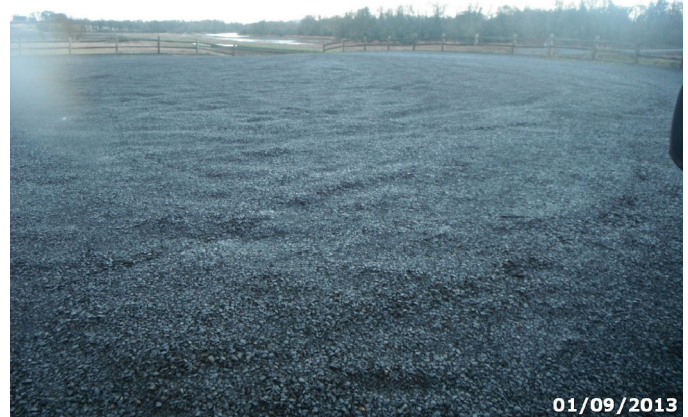
**Route Number: 907**  
**Bruce Road Overlook Parking**  
**From Bruce Road**

Asset Number	Area (Sq Ft)	Spaces	Condition	Surface Type	Cost to Improve	Inspection Date	Current Replacement Value
10004443	12200	15	Excellent	Gravel	\$0	01-09-2013	\$69,100

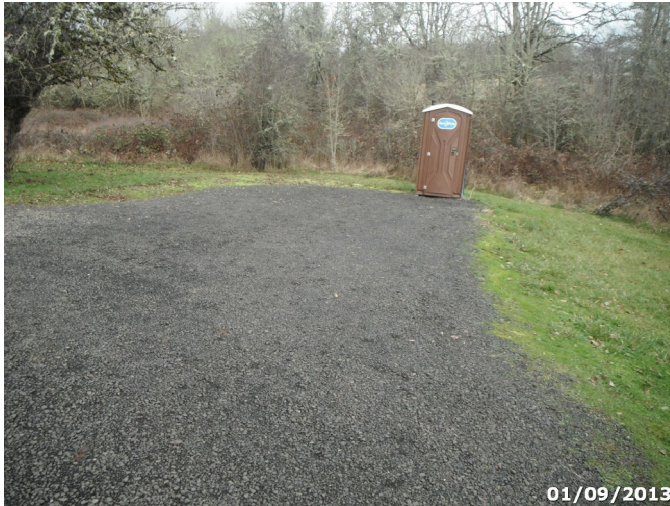
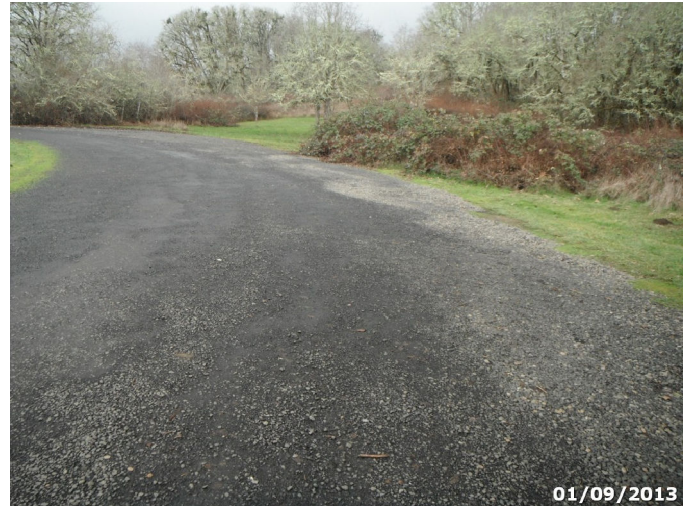
**Route Number: 908**  
**Woodpecker Loop Parking**  
 From Woodpecker Loop Road (Route 101)

Asset Number	Area (Sq Ft)	Spaces	Condition	Surface Type	Cost to Improve	Inspection Date	Current Replacement Value
10048913	2516	15	Good	Gravel	\$400	01-09-2013	\$14,300

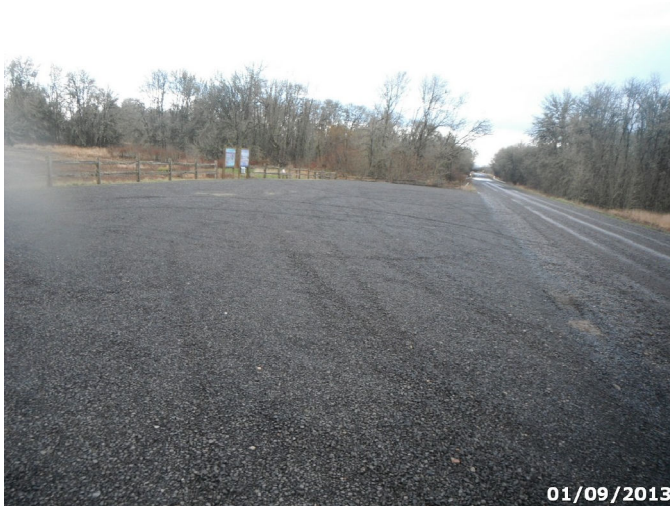
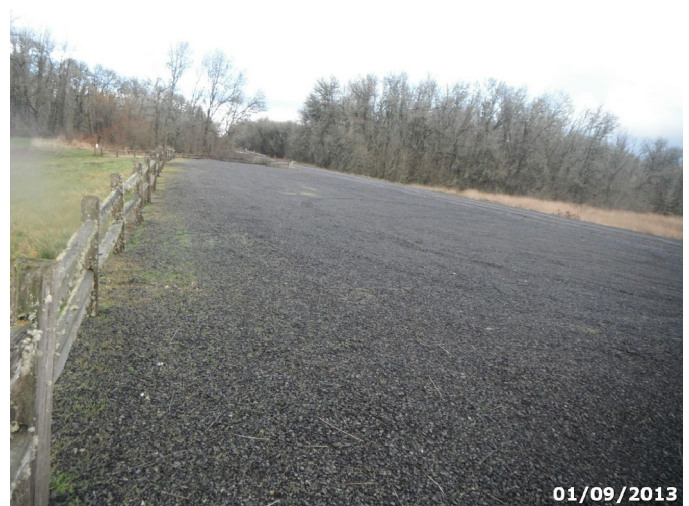
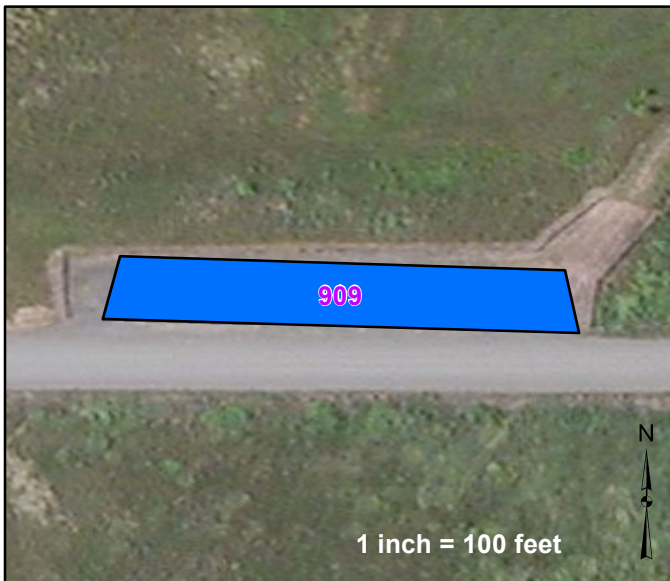
**Route Number: 909**  
**Cheadle Marsh Parking**  
**From Bruce Road**

Asset Number	Area (Sq Ft)	Spaces	Condition	Surface Type	Cost to Improve	Inspection Date	Current Replacement Value
10048181	5643	10	Excellent	Gravel	\$0	01-09-2013	\$32,000

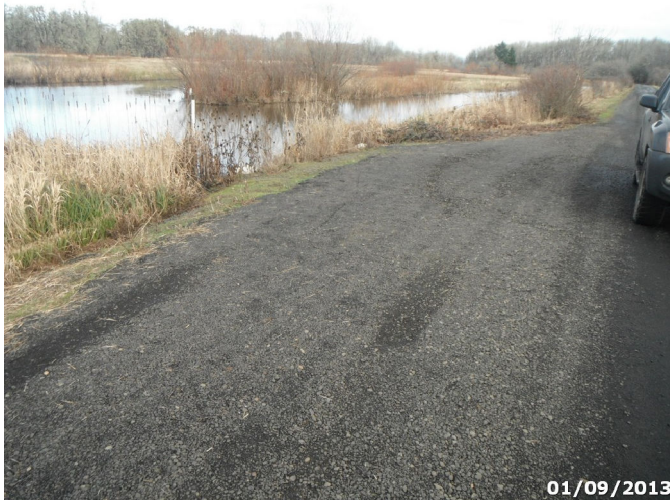
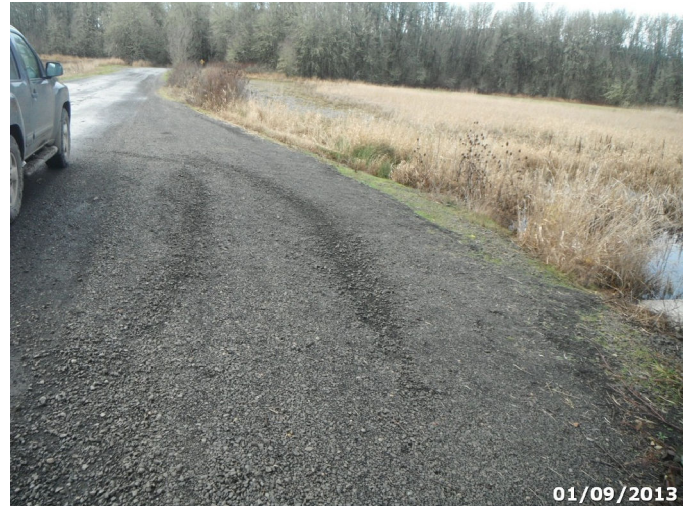
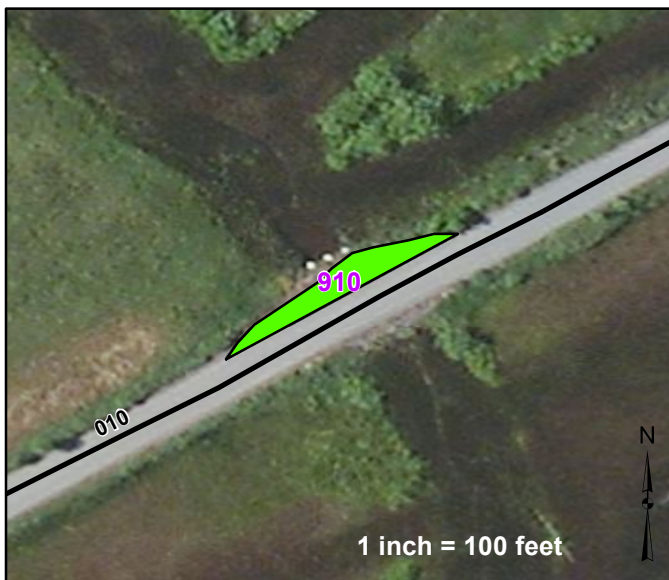
**Route Number: 910**  
**Vehicle Turnout at Turtle Flats West**  
 From Finley Refuge Road (Route 010)

Asset Number	Area (Sq Ft)	Spaces	Condition	Surface Type	Cost to Improve	Inspection Date	Current Replacement Value
10048903	1007	5	Good	Gravel	\$200	01-09-2013	\$5,700

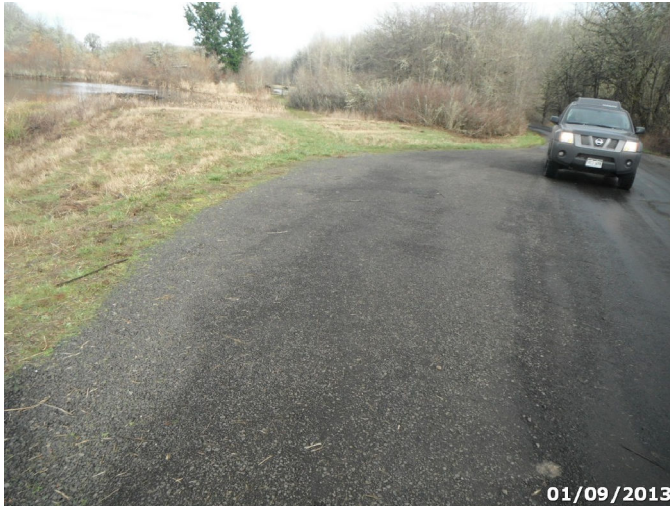
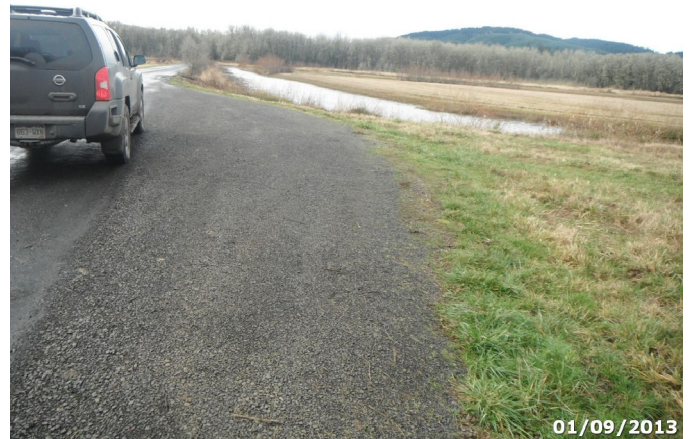
## Route Number: 911

Asset Number	Area (Sq Ft)	Spaces	Condition	Surface Type	Cost to Improve	Inspection Date	Current Replacement Value
10048881	1196	5	Good	Gravel	\$200	01-09-2013	\$6,800

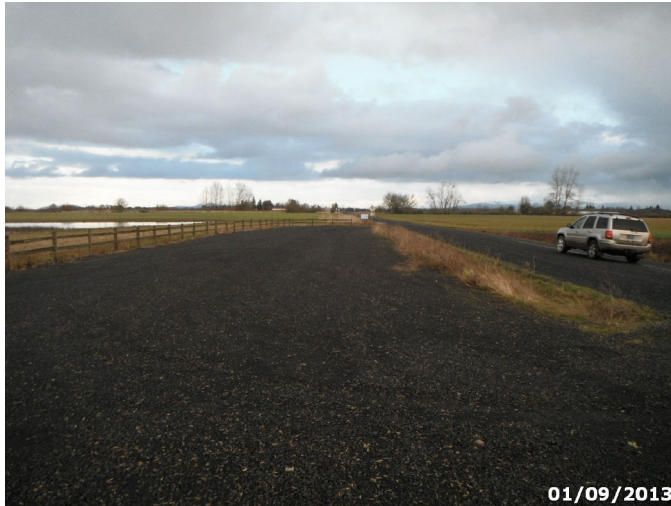
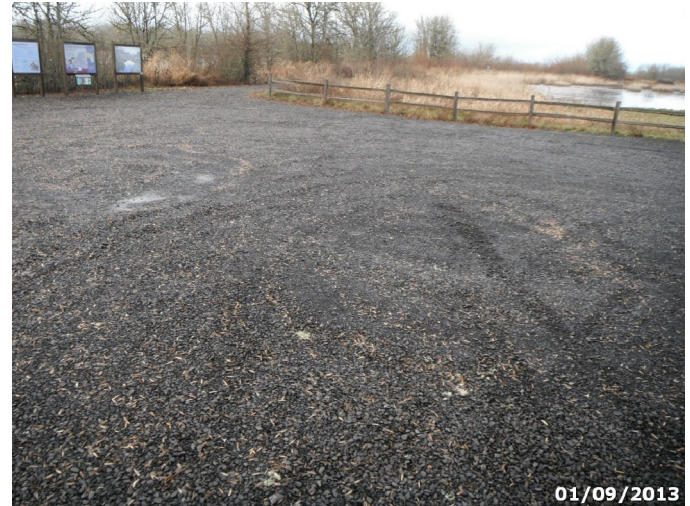
**Route Number: 912**  
**McFadden Marsh Observation Blind Parking**  
**From Bruce Road**

Asset Number	Area (Sq Ft)	Spaces	Condition	Surface Type	Cost to Improve	Inspection Date	Current Replacement Value
10048197	13493	20	Excellent	Gravel	\$0	01-09-2013	\$76,500

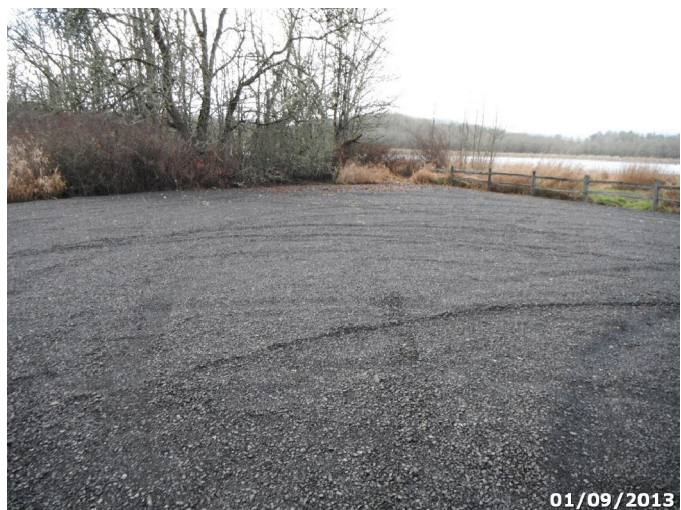
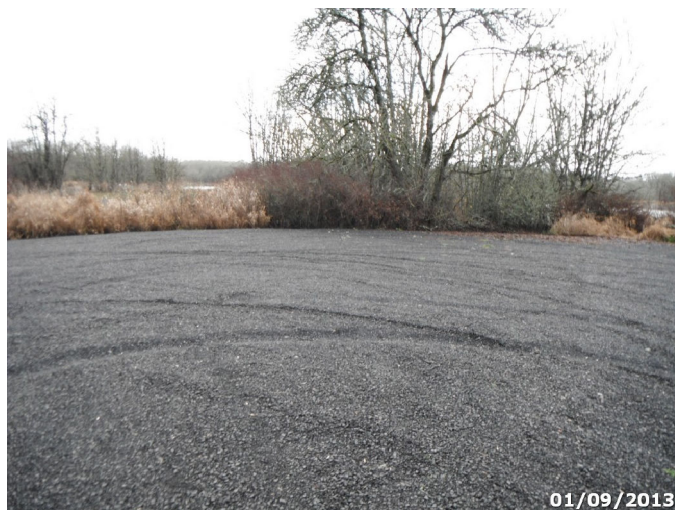
**Route Number: 913**  
**McFadden Marsh East Parking Lot**  
**From Bruce Road**

Asset Number	Area (Sq Ft)	Spaces	Condition	Surface Type	Cost to Improve	Inspection Date	Current Replacement Value
10048196	6085	5	Good	Gravel	\$1,000	01-09-2013	\$34,500

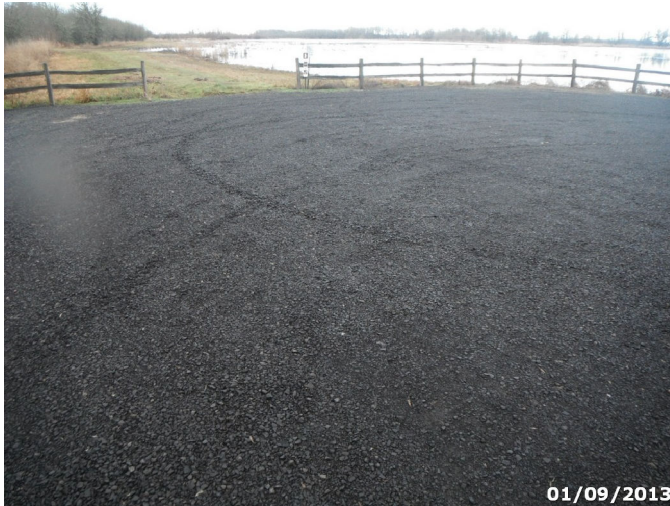
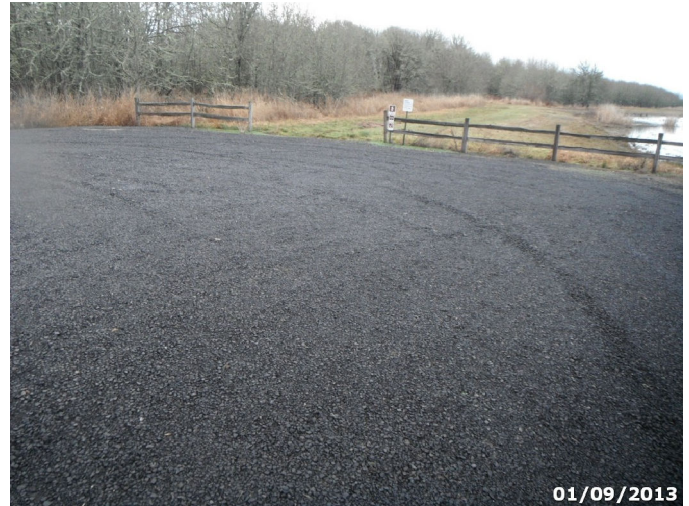
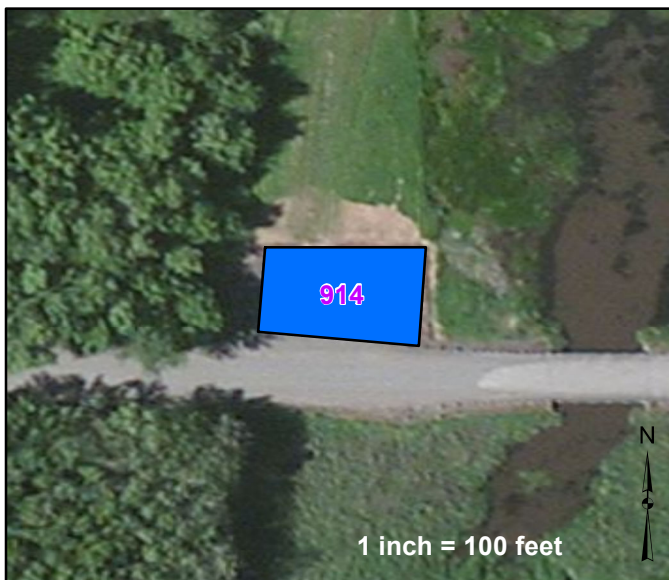
**Route Number: 914**  
**McFadden Marsh West Parking Lot**  
**From Bruce Road**

Asset Number	Area (Sq Ft)	Spaces	Condition	Surface Type	Cost to Improve	Inspection Date	Current Replacement Value
10048192	2857	10	Excellent	Gravel	\$0	01-09-2013	\$16,200

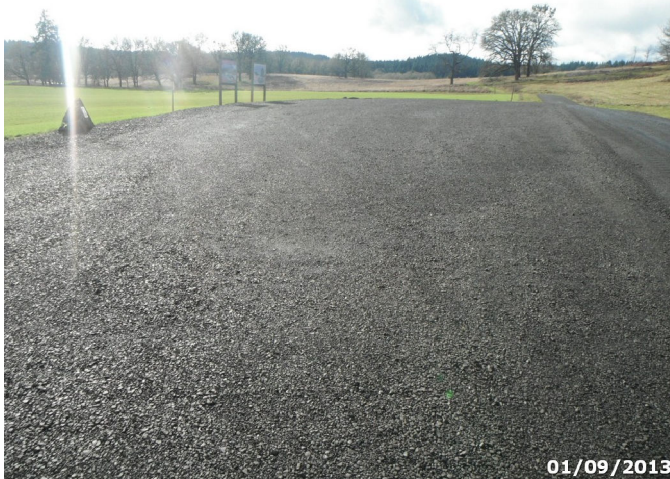
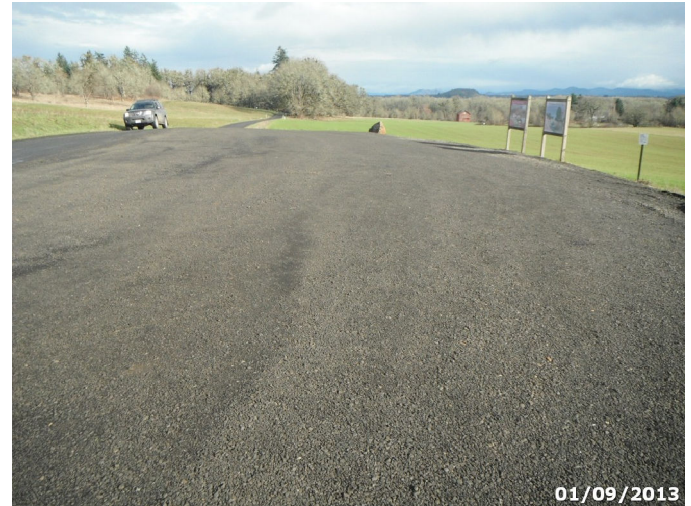
**Route Number: 915**  
**Field #22 Vehicle Turnout**  
**From Finley Refuge Road (Route 010)**

Asset Number	Area (Sq Ft)	Spaces	Condition	Surface Type	Cost to Improve	Inspection Date	Current Replacement Value
10048883	5956	5	Excellent	Gravel	\$0	01-09-2013	\$33,700

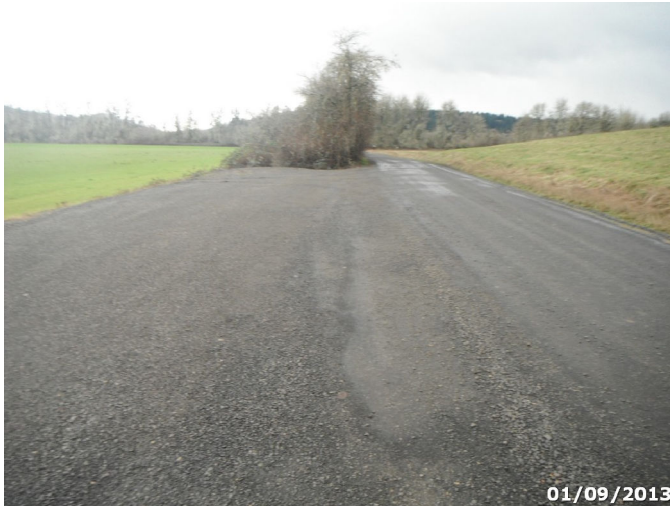
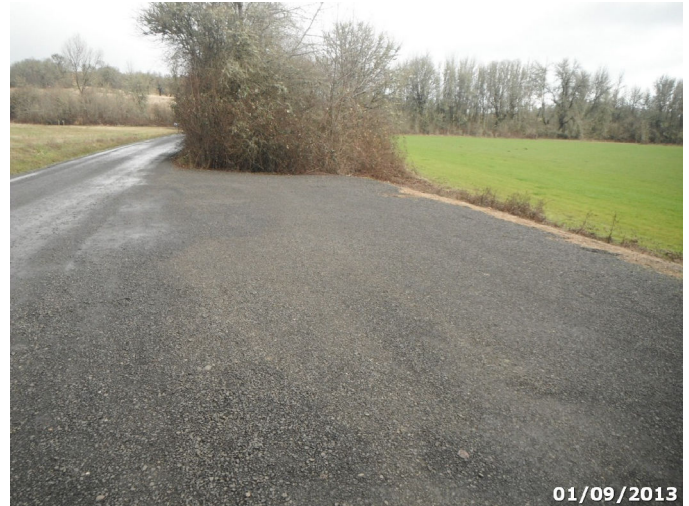
## Route Number: 916

Asset Number	Area (Sq Ft)	Spaces	Condition	Surface Type	Cost to Improve	Inspection Date	Current Replacement Value
10048884	3766	5	Excellent	Gravel	\$0	01-09-2013	\$21,300

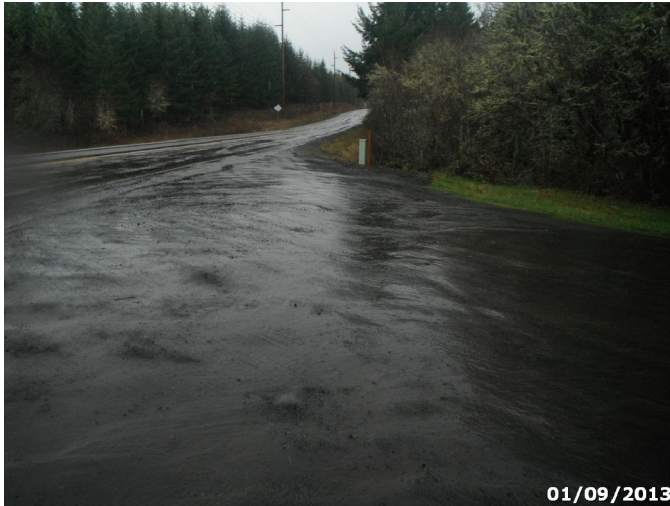
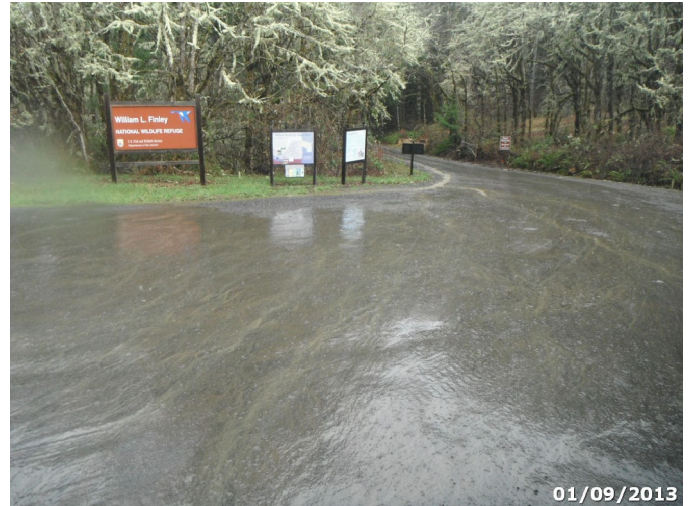
**Route Number: 917**  
**Vehicle Turnout at Bellfountain Entrance**  
 From Finley Refuge Road (Route 010)

Asset Number	Area (Sq Ft)	Spaces	Condition	Surface Type	Cost to Improve	Inspection Date	Current Replacement Value
-	1222	5	Fair	Gravel	\$400	01-09-2013	\$6,900

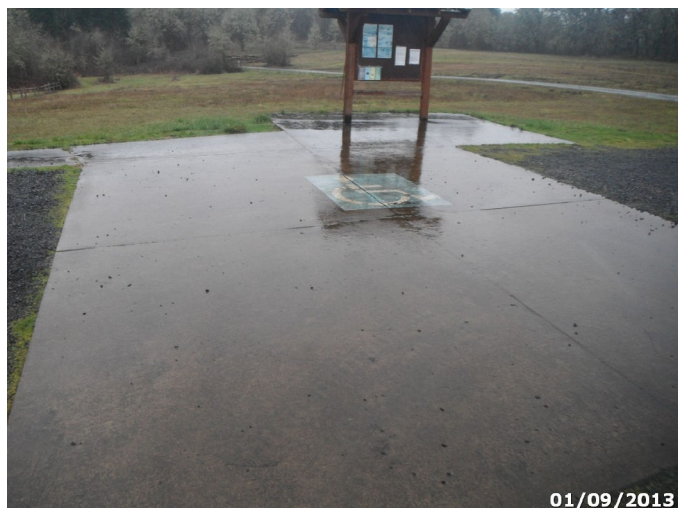
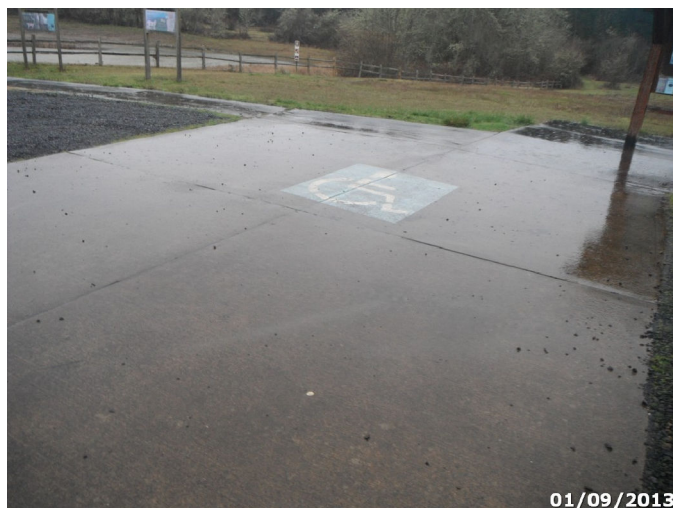
**Route Number: 918**  
**Mill Hill Trail HC Parking**  
 From Mill Hill Trail Parking (Route 905)

Asset Number	Area (Sq Ft)	Spaces	Condition	Surface Type	Cost to Improve	Inspection Date	Current Replacement Value
-	317	1	Good	Concrete	\$100	01-09-2013	\$4,000

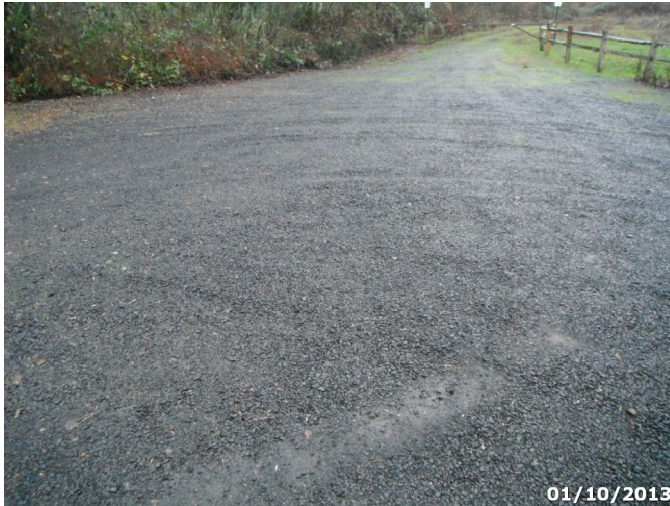
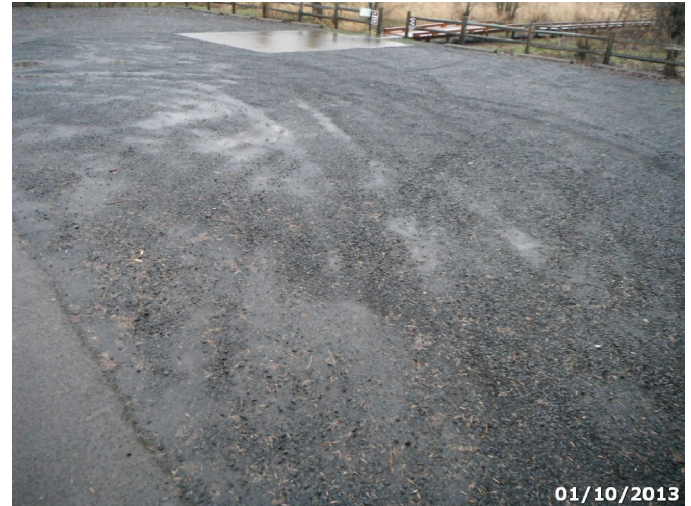
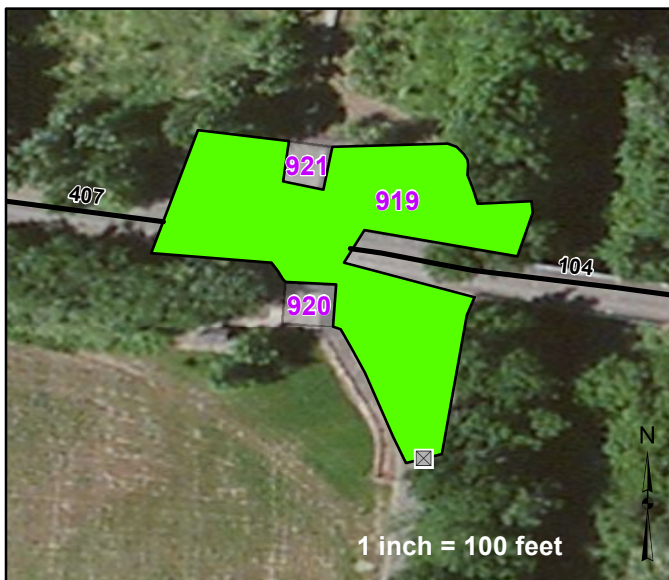
**Route Number: 919**  
**Snag Boat Bend West Parking**  
**From Snag Boat Bend West Access (Route 104)**

Asset Number	Area (Sq Ft)	Spaces	Condition	Surface Type	Cost to Improve	Inspection Date	Current Replacement Value
-	10081	40	Good	Gravel	\$1,700	01-10-2013	\$57,100

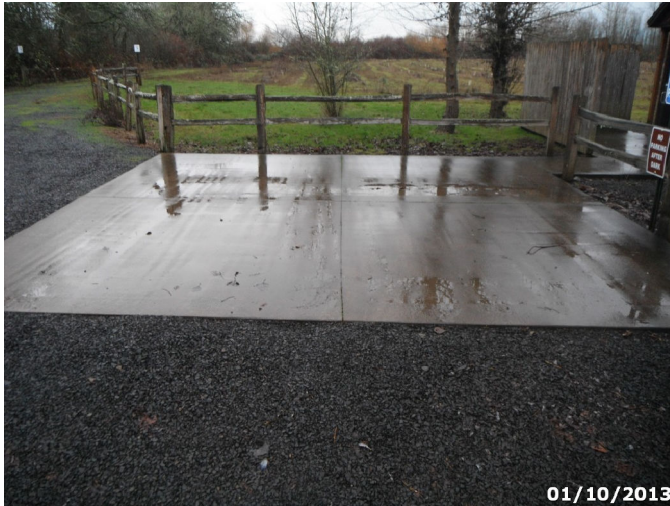
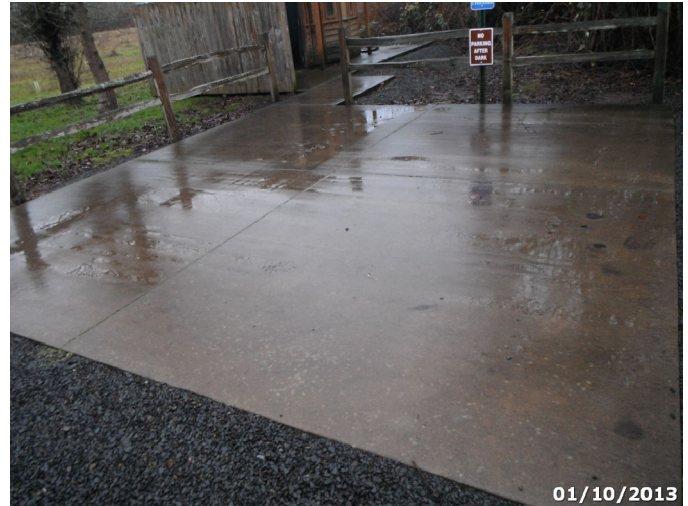
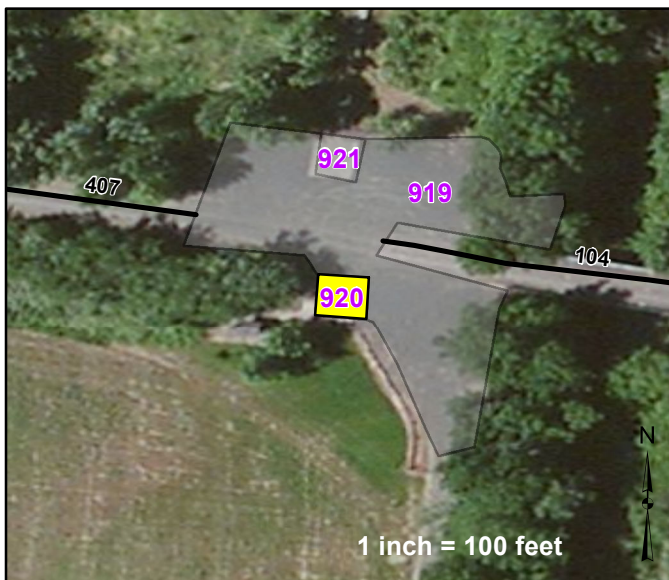
**Route Number: 920**  
**Snag Boat Bend Handicapped Parking North**  
 From Snag Boat Bend West Parking (Route 919)

Asset Number	Area (Sq Ft)	Spaces	Condition	Surface Type	Cost to Improve	Inspection Date	Current Replacement Value
10048575	408	1	Fair	Concrete	\$800	01-10-2013	\$5,100

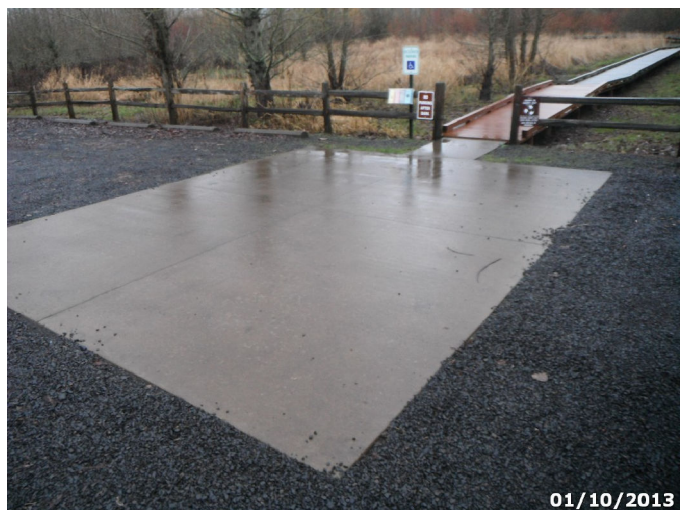
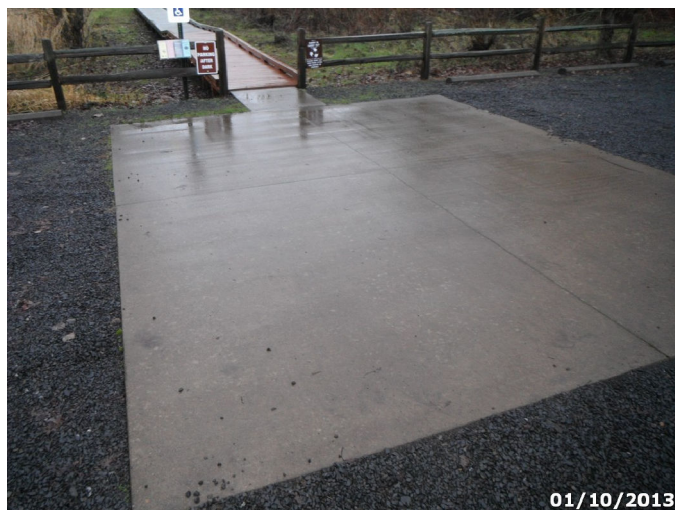
**Route Number: 921**  
**Snag Boat Bend Handicapped Parking South**  
 From Snag Boat Bend West Parking (Route 919)

Asset Number	Area (Sq Ft)	Spaces	Condition	Surface Type	Cost to Improve	Inspection Date	Current Replacement Value
-	347	1	Fair	Concrete	\$700	01-10-2013	\$4,400

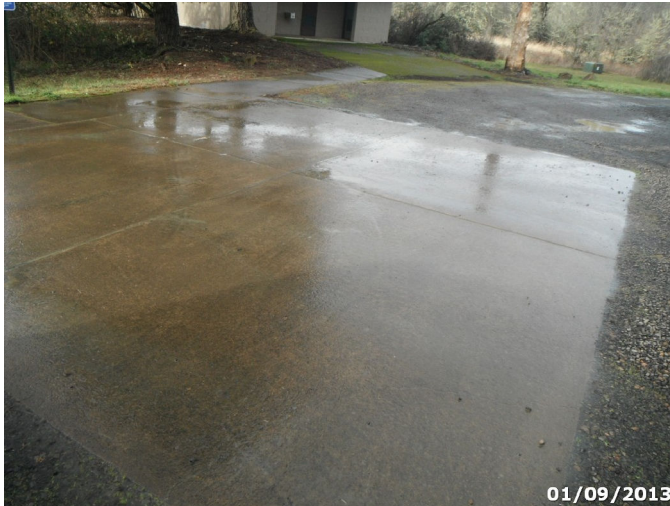
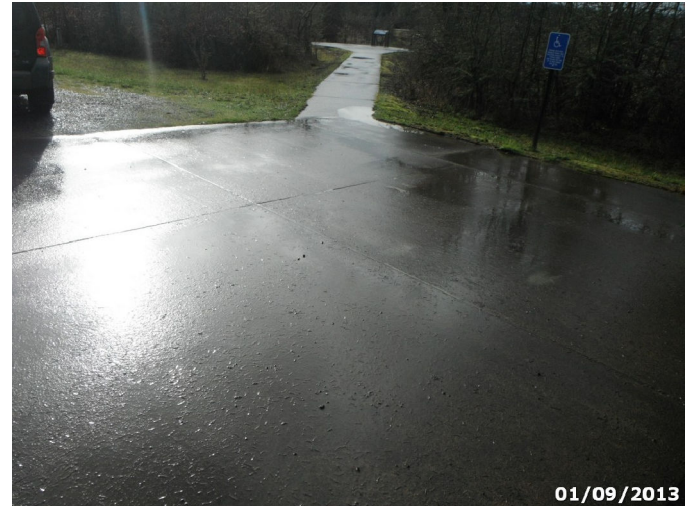
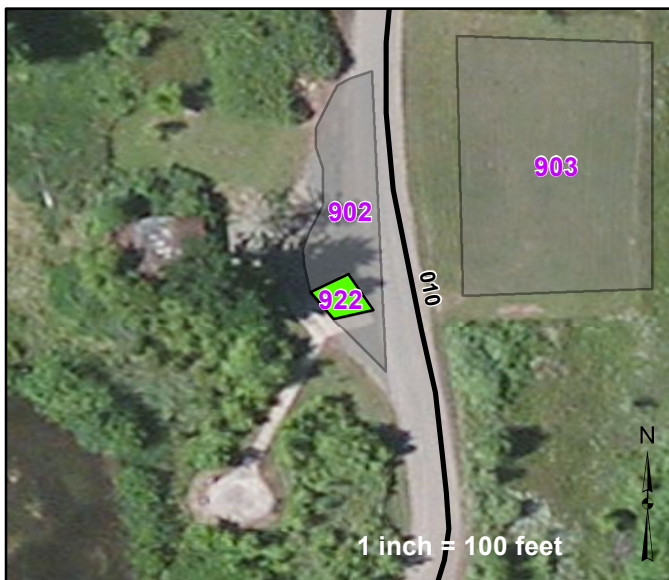
## Route Number: 922

Asset Number	Area (Sq Ft)	Spaces	Condition	Surface Type	Cost to Improve	Inspection Date	Current Replacement Value
-	300	1	Good	Concrete	\$0	01-09-2013	\$3,800
